BUILDING-STRUCTURE INVENTORY FORM

1. BUILDING NAME(S): Elmgrove School (District No. 12)
2. COUNTY: Monroe TOWN: Greece
3. STREET LOCATION: 463 Elmgrove Road (northwest corner of Elmore Drive)
4. OWNERSHIP: a. public ☐ b. private ☒
5. PRESENT OWNER: Leo & Helen Quanz ADDRESS: 1679 Hilton-Parma Road
Spencerport, NY 14559
6. USE: Original: School Present: Apartments
7. ACCESSIBILITY TO PUBLIC: Exterior visible from public road: Yes ☒ No ☐
Interior accessible: Explain private apartments

Town of Greece Historic Sites Survey
Monroe County, New York
463 Elmgrove Road
page 5

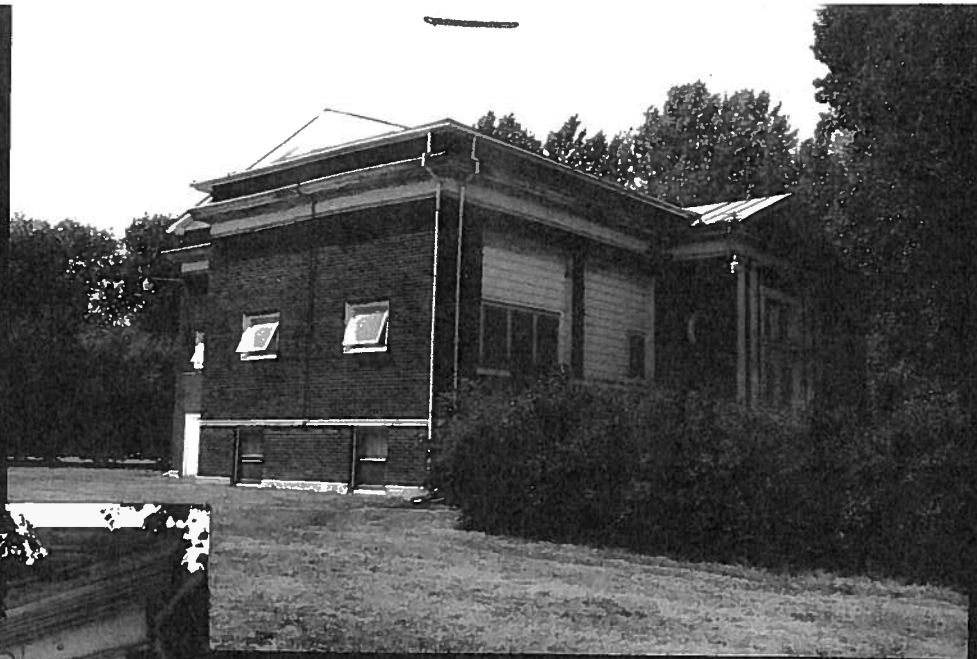
12. PHOTO:

Front (east) elevation: Most of the original windows have been removed, the openings filled, aluminum siding installed, and smaller double-hung windows installed. Jalousie windows added at front door.

The original windows on the first floor of the facade have been removed and the openings partially covered with aluminum siding, and smaller six-over-six, double-hung replacement windows installed.

"This building comes with the problem of the changed windows. Let's make it a 'green plus' with the stipulation that with sensitive rehabilitation it could be a 'red.' This was really an architect-designed building and has inherent quality to it. It would be nice if it was restored." P.Malo.
